**CRYOGENIC FLUID
MANAGEMENT EXPERIMENT
TRUNNION VERIFICATION TESTING**

by W.J. Bailey, and D.A. Fester

MARTIN MARIETTA DENVER AEROSPACE

1. Report No. NASA CR-168310		2. Government Accession No.		3. Recipient's Catalog No.	
4. Title and Subtitle Cryogenic Fluid Management Experiment (CFME) Trunnion Verification Testing				5. Report Date December 1983

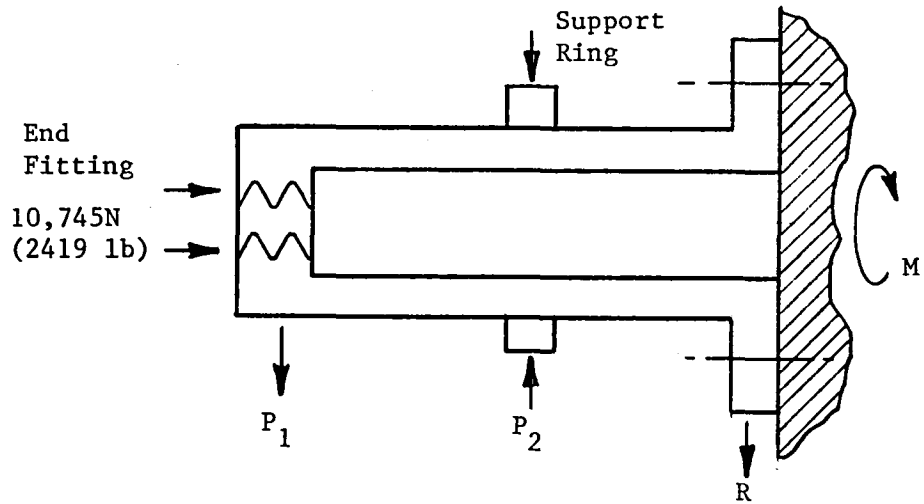
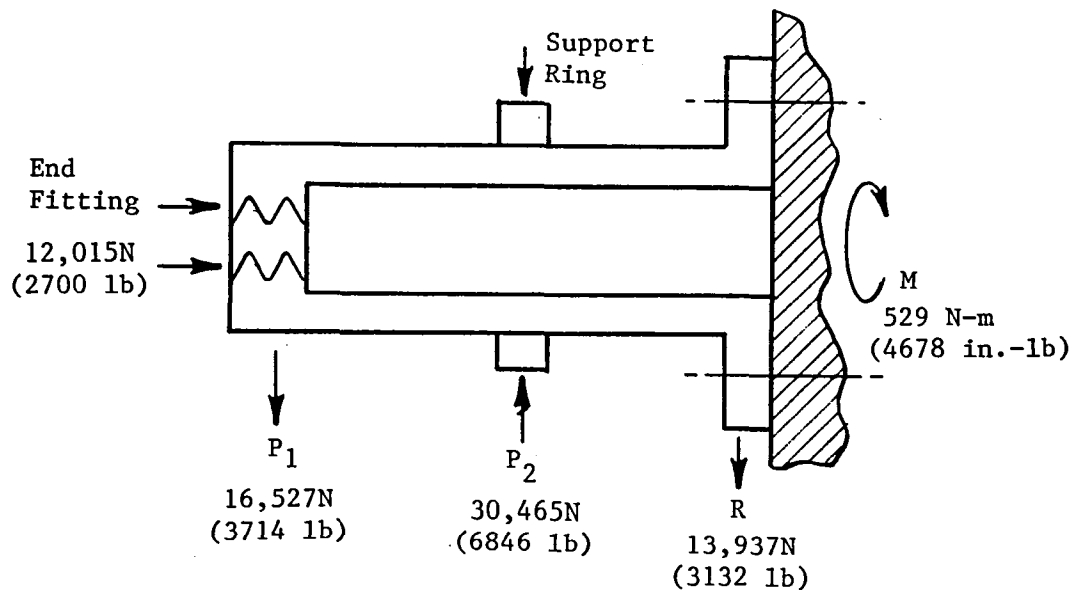
Figure III-3 Trunnion Fatigue Loading Conditions

A review of the prior trunnion analysis was initiated to insure that loading and spectral conditions planned for the Task III trunnion fatigue test were proper. A verification of the critical loading conditions for the CFME trunnion test was completed; results are summarized by the diagrams in Figure III-2. The analysis indicated that the original limit loading conditions, shown in Figure III-3, required updating due to the following:

1. An increase of 57.2 kg (26 lb) in the supported weight on the trunnions not accounted for in the original analysis. This effect contributes the largest increase in load at P_1 and P_2 .
2. Consideration of moment effect of pressure vessel C.G. offset in the X-Y plane (see Reference 4, page 249). This effect adds load in the X component direction and thereby increases P_1 and P_2 .

P_1	P_2	R	M
Loading Condition 1:	8055N (1810 lb)	20,136N (4525 lb)	12,082N (2715 lb)	0 N-m (0 in.-lb)
Loading Condition 2:	7552N (1697 lb)	19,633N (4412 lb)	12,082N (2715 lb)	182 N-m (1612 in.-lb)

3. Consideration of the 2.29-cm (0.9-in.) moment arm measured between the center of the membrane shell and the trunnion flange/boss interface. This effect increases the resultant loads (reactions) P_1 and P_2 .
4. The original loading condition 1 was found to be inconsistent with the final stress analysis because of an imbalance of 131.42 N-m (1163 in-lb) moment that was not shown. Also, loading condition 2 was unconservative in that the moment acted as a relieving moment, when in fact this moment should have been considered as a reinforcing moment for worse case conditions.

The new loading conditions for the trunnion fatigue tests are also shown in Figure III-3. Stress analysis and dynamic computer modeling indicated that a loading condition with a resulting moment at the flange was more critical in the area of the spacer while imposing, at the same time, the greater stress at the flange. Therefore, the trunnions were tested in fatigue using the most critically determined loading case which resulted in the higher trunnion stress.

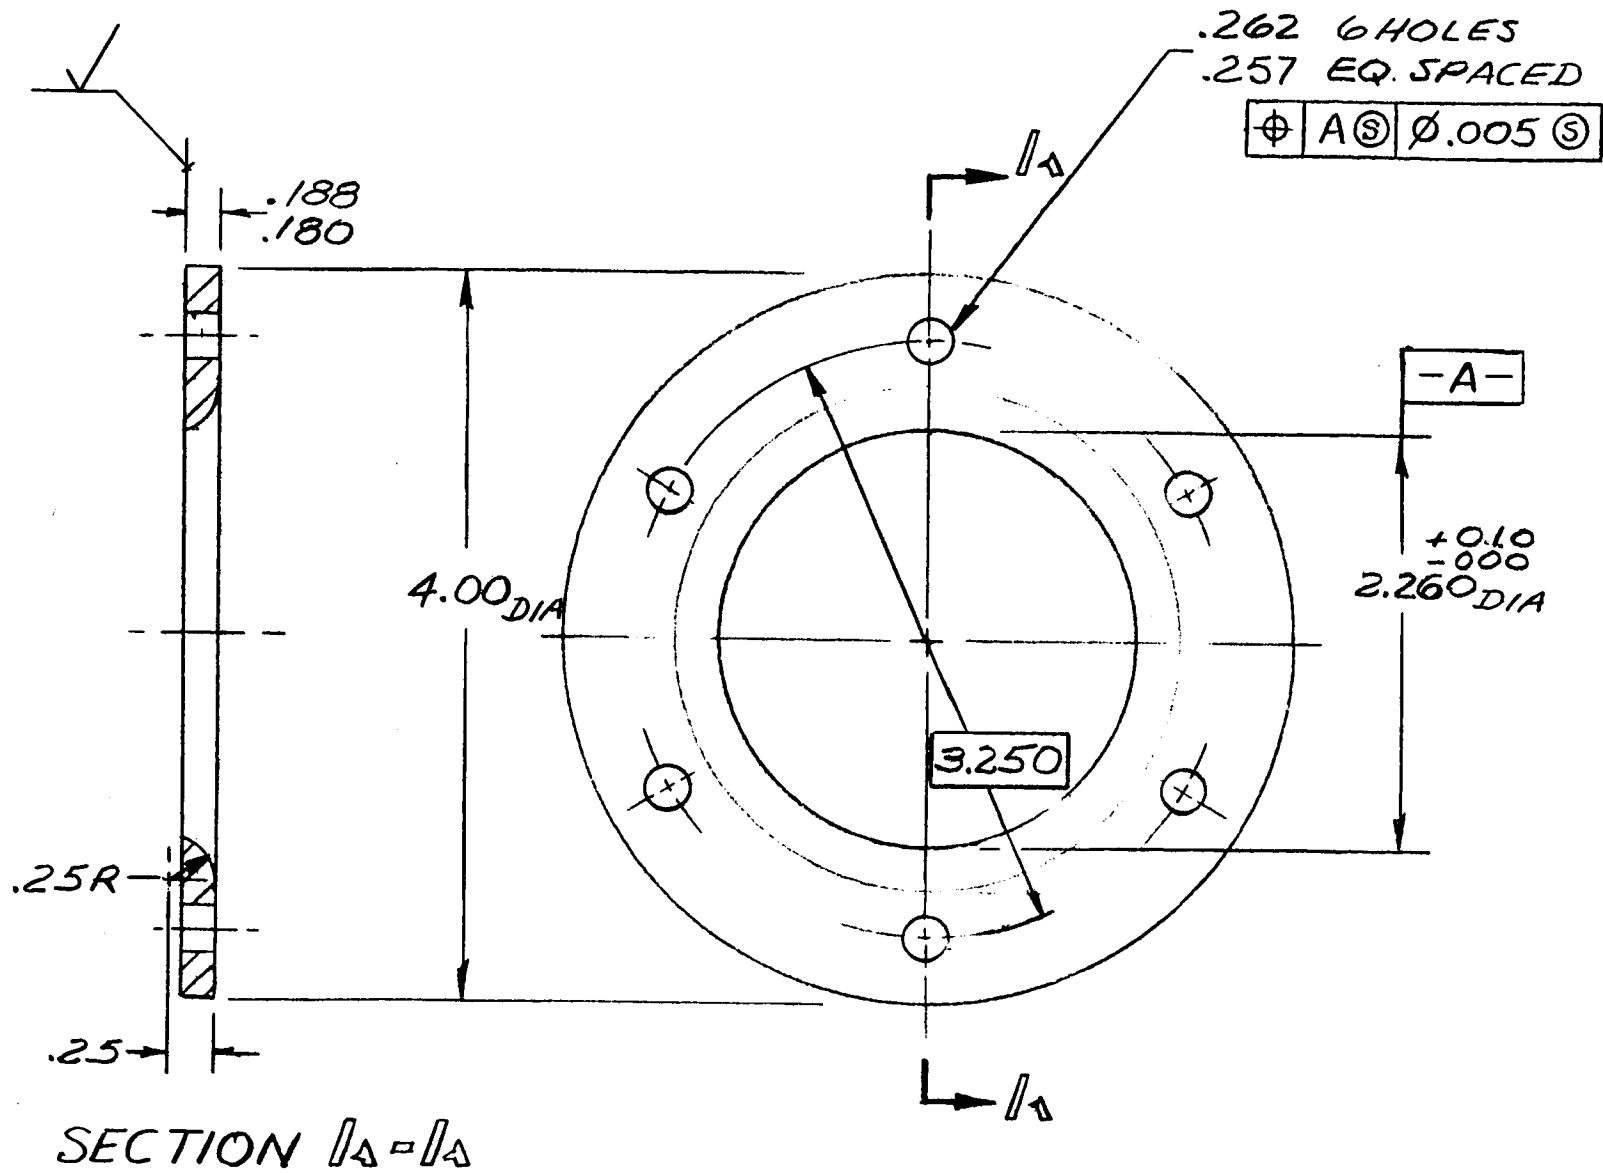
Figure III-6 Back-up Ring Assembly

7. Potential delamination of the plies at the trunnion cylinder/flange radius became a concern under the fatigue loading conditions. Complexities of the laminate configuration in this area made analysis highly questionable based on unknowns and assumptions which would have to be made. By increasing the thickness of the metal ring support installed on the flange (which formerly was used to distribute bolting loads uniformly around the flange) and creating an area of close fit at the radius, additional load support and some possible delamination prevention were provided. In this manner, uncertainties were minimized and design confidence was increased. Figure III-6 shows details of the back-up ring and Figure III-7 shows the ring installation on the trunnion. The ring was installed during trunnion fabrication before the spacer was put in place.

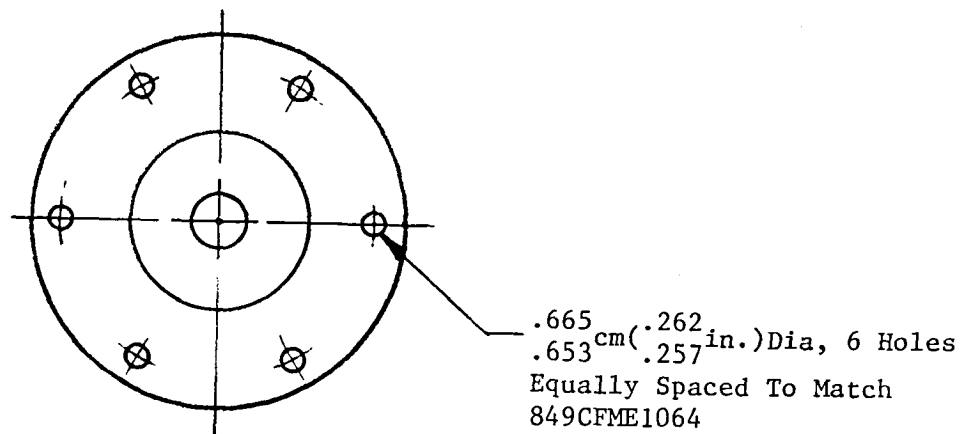
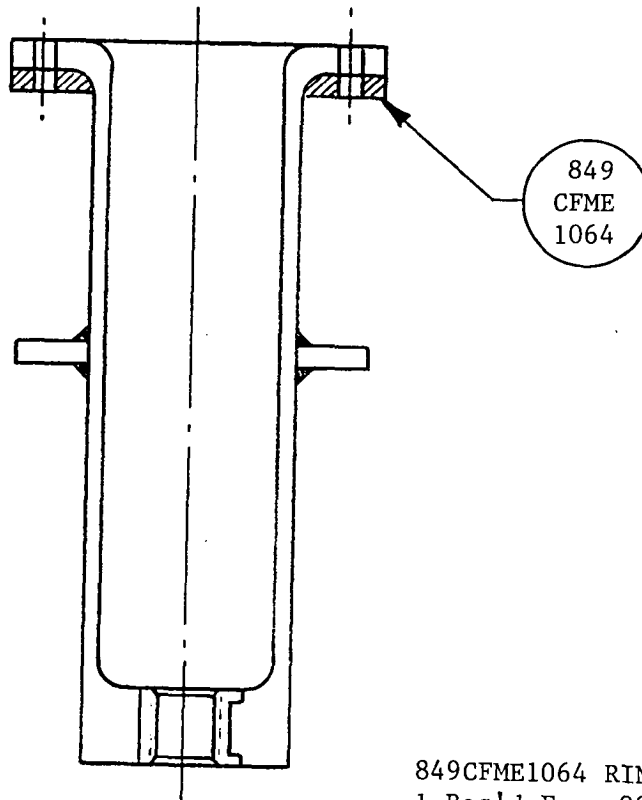
Figure III-7 Back-up Ring Installation

849CFME1064 RING, BACKUP
 1 Req'd For -009 Assy

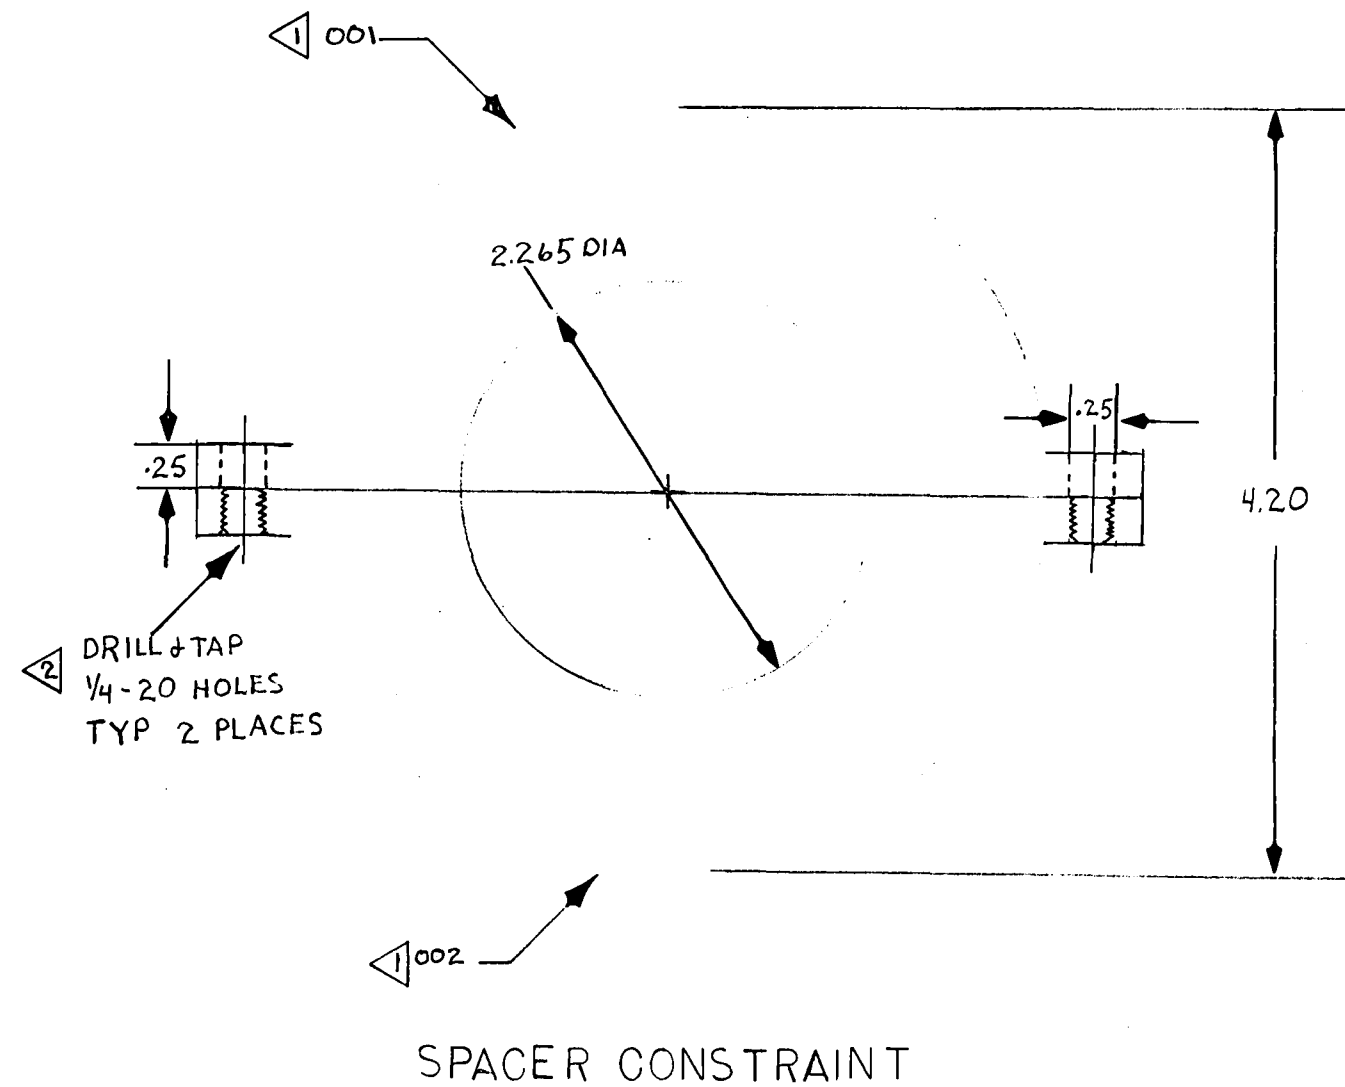
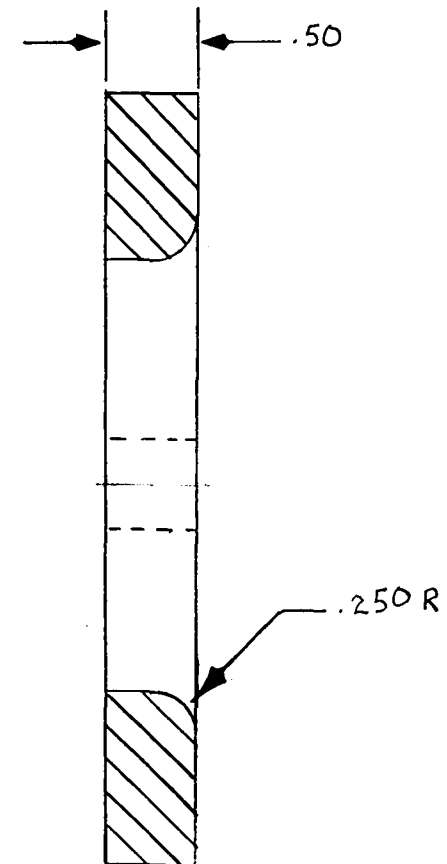
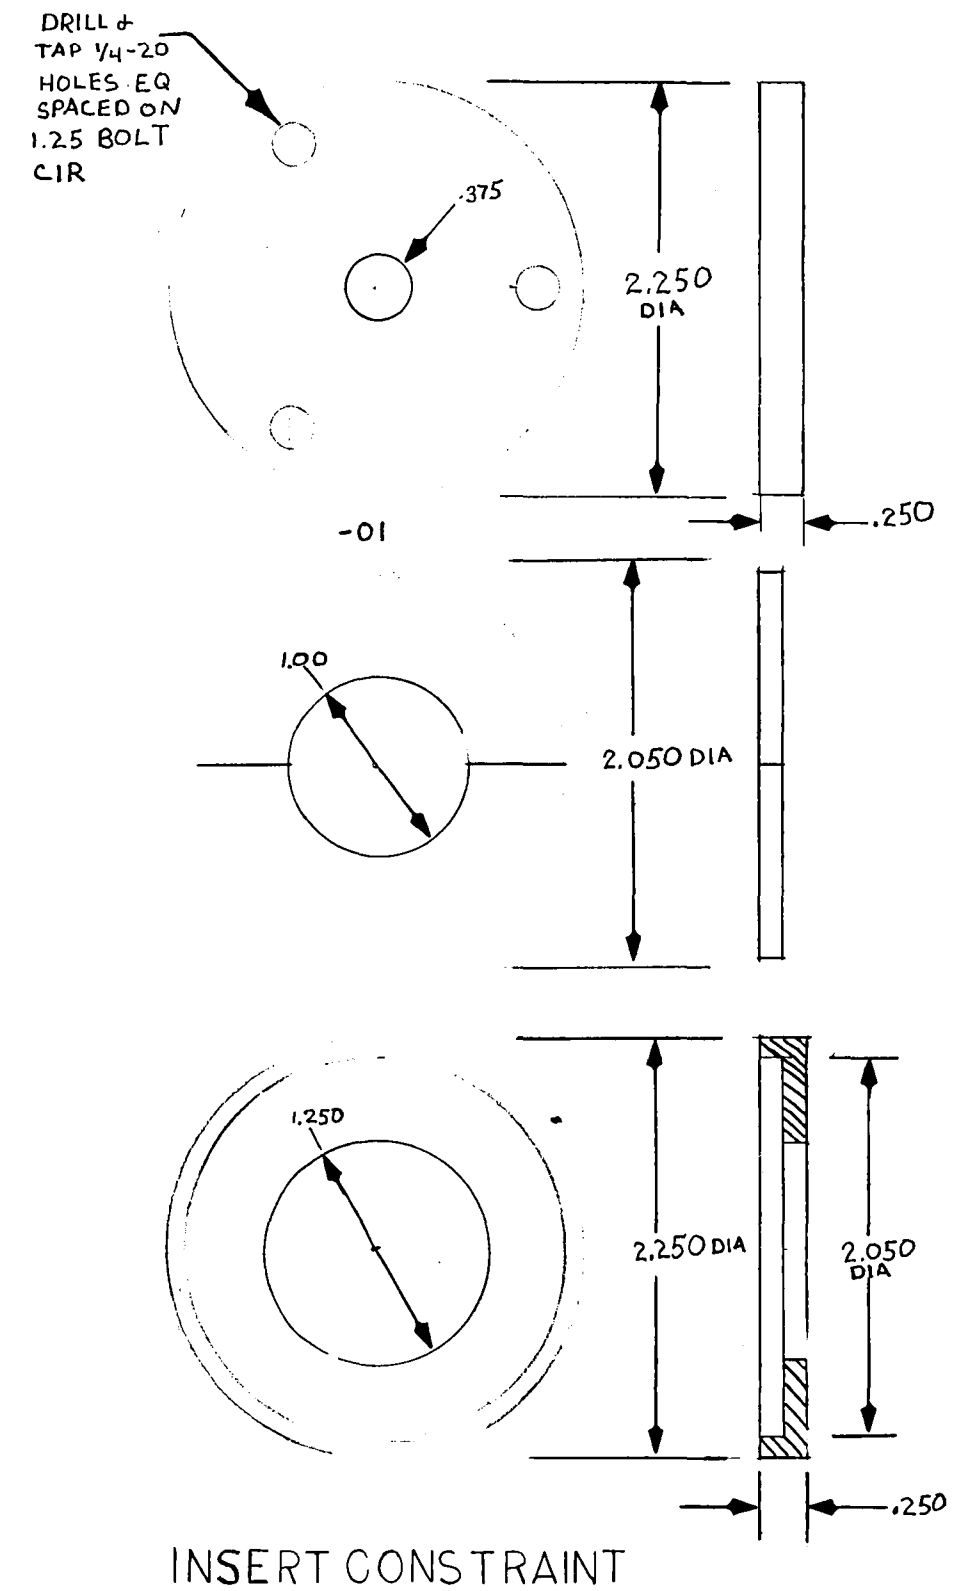
Figure IV-4 End Insert and Spacer Constraint Tooling

1 001 + 002 BOLTED
TOGETHER TO BE
MATCH MACHINED

2 1/4-20 BOLT, 1.00
IN LENGTH

- 10) Install -006 and -012 disc. Bond -006 disc per eng. dwg. Note 10. Attach top constraint fixture (Figure IV-4). Fill void areas with hoop oriented S-glass roving pre-preg per eng. dwg. Note 9.

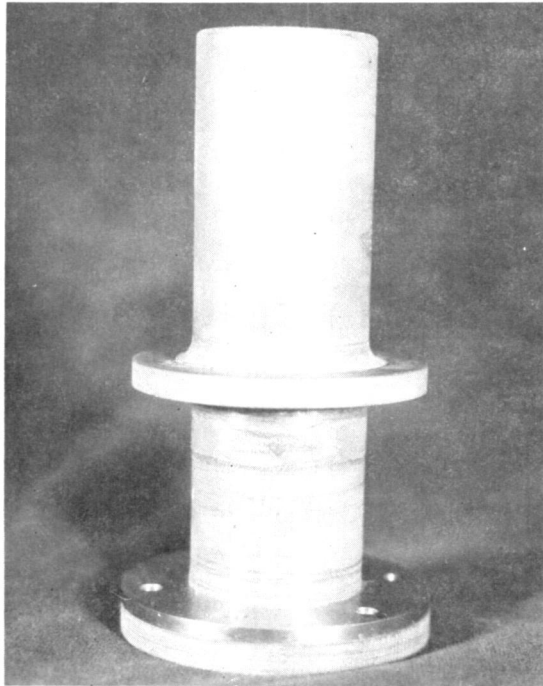
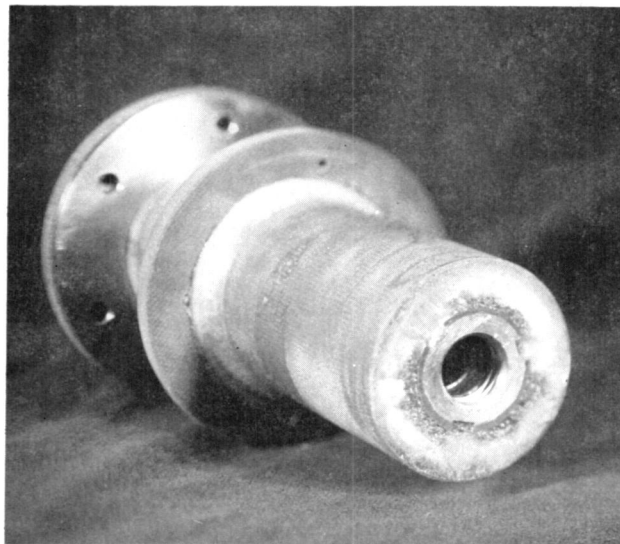
Figure IV-7 Fixed Trunnion Configuration

Figure IV-7 shows a side and an end view of a completed fixed trunnion configuration. Figure IV-8 shows a front and a side view of a completed floating trunnion configuration.

Three trunnions were tested. One was manufactured according the revised drawing 849CFME1036 (fixed type which includes a threaded titanium insert) while two were manufactured according to revised drawing 849CFME1035 (floating type with an open end). The cylindrical portion of the trunnion was composed of fiberglass/epoxy composite similar to that used in the test specimen for the laminate mechanical properties tests.

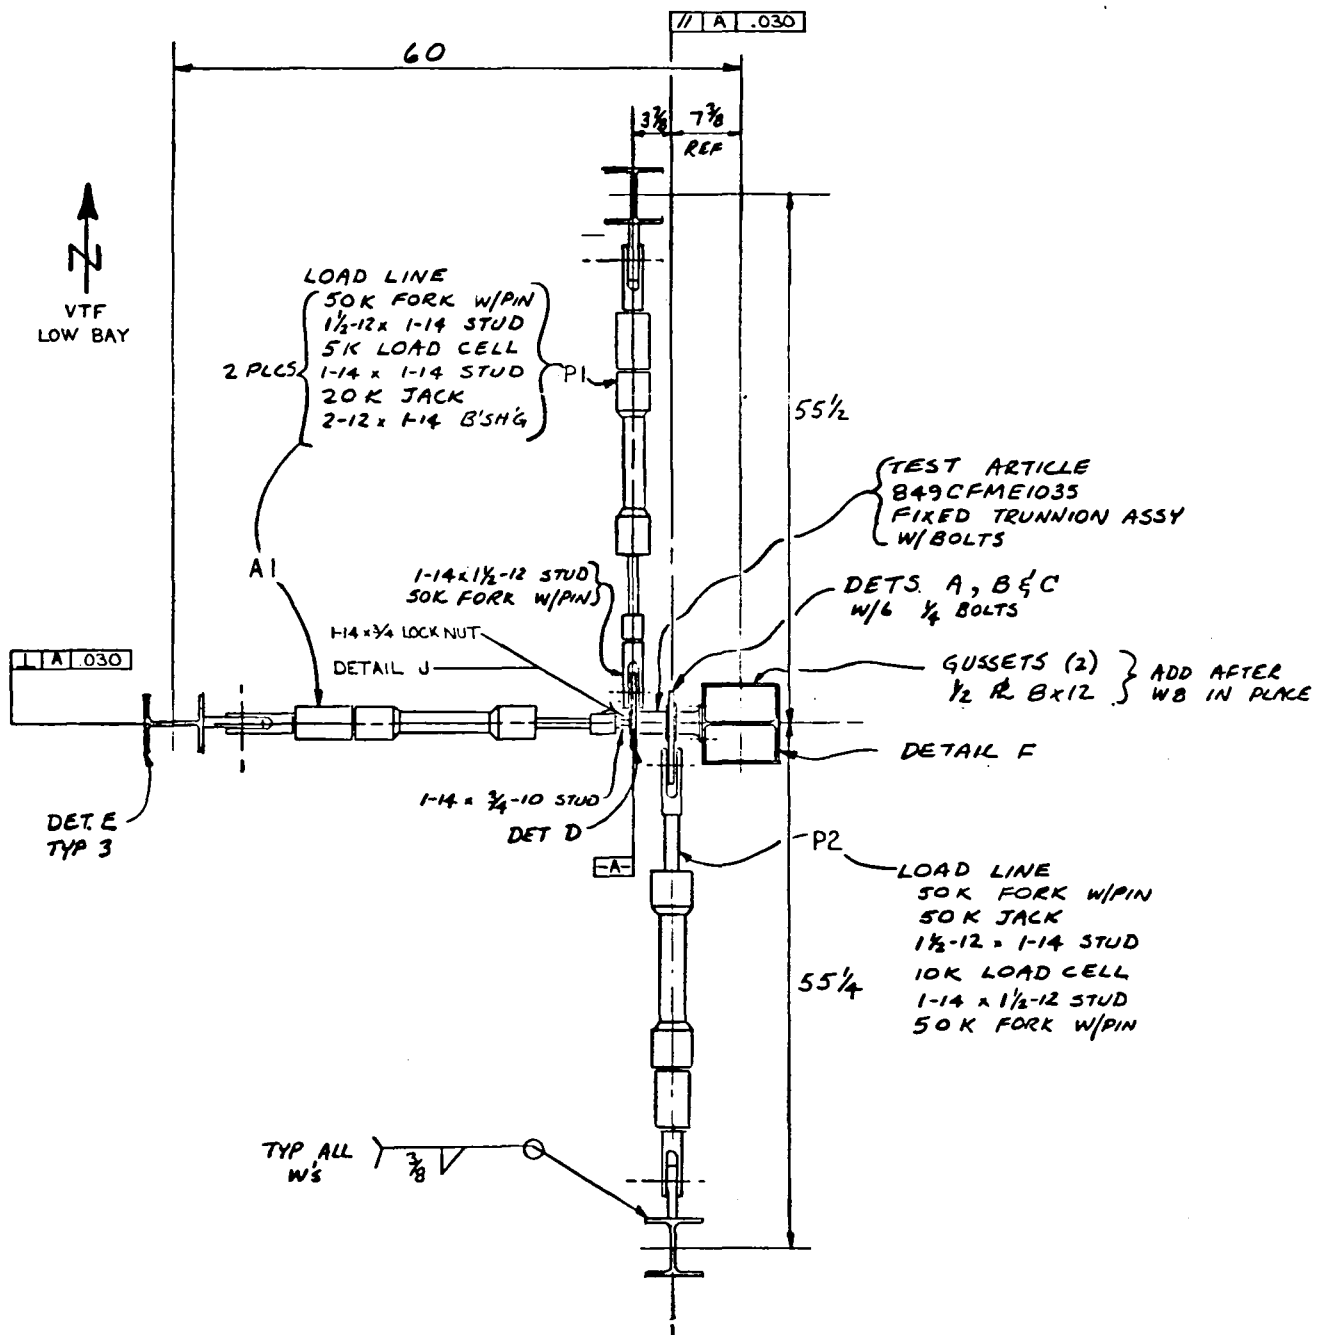
Figure IV-9 CFMF Trunnion Fatigue Test Setup

One stress cycle consisted of the concurrent application of loads P₁ and P₂ by actuators 1 and 2 until the maximum loading condition was achieved followed by relaxing the loads concurrently until the minimum loading condition was achieved. Loading directions were reversed only when the minimum loading became negative (see Table III-2). The spectrum was applied to the floating trunnions in the following manner until 20,000 cycles were reached:

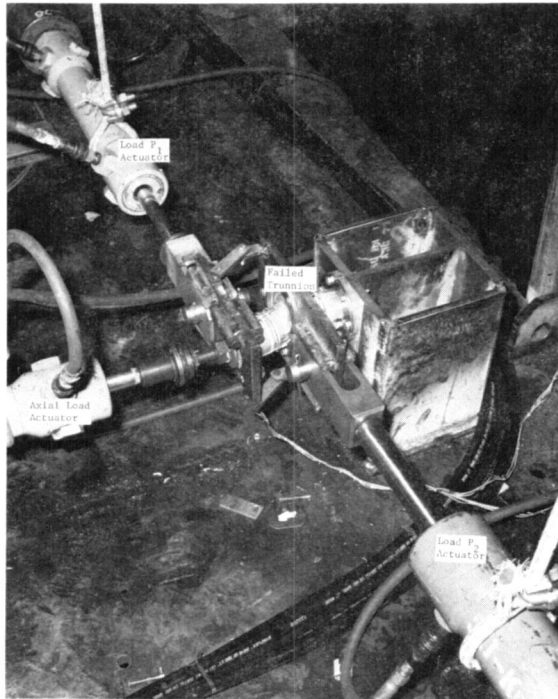
Figure IV-12 Failed CFME Fixed Trunnion in Fatigue Test Setup

After the fatigue test was complete, another static test was performed with loads applied in 10% increments of limit load until 150% of limit load was reached. Margin testing was then conducted using the distribution shown in Table III-3 for 2,540 cycles. The fixed trunnion was then static tested to failure.

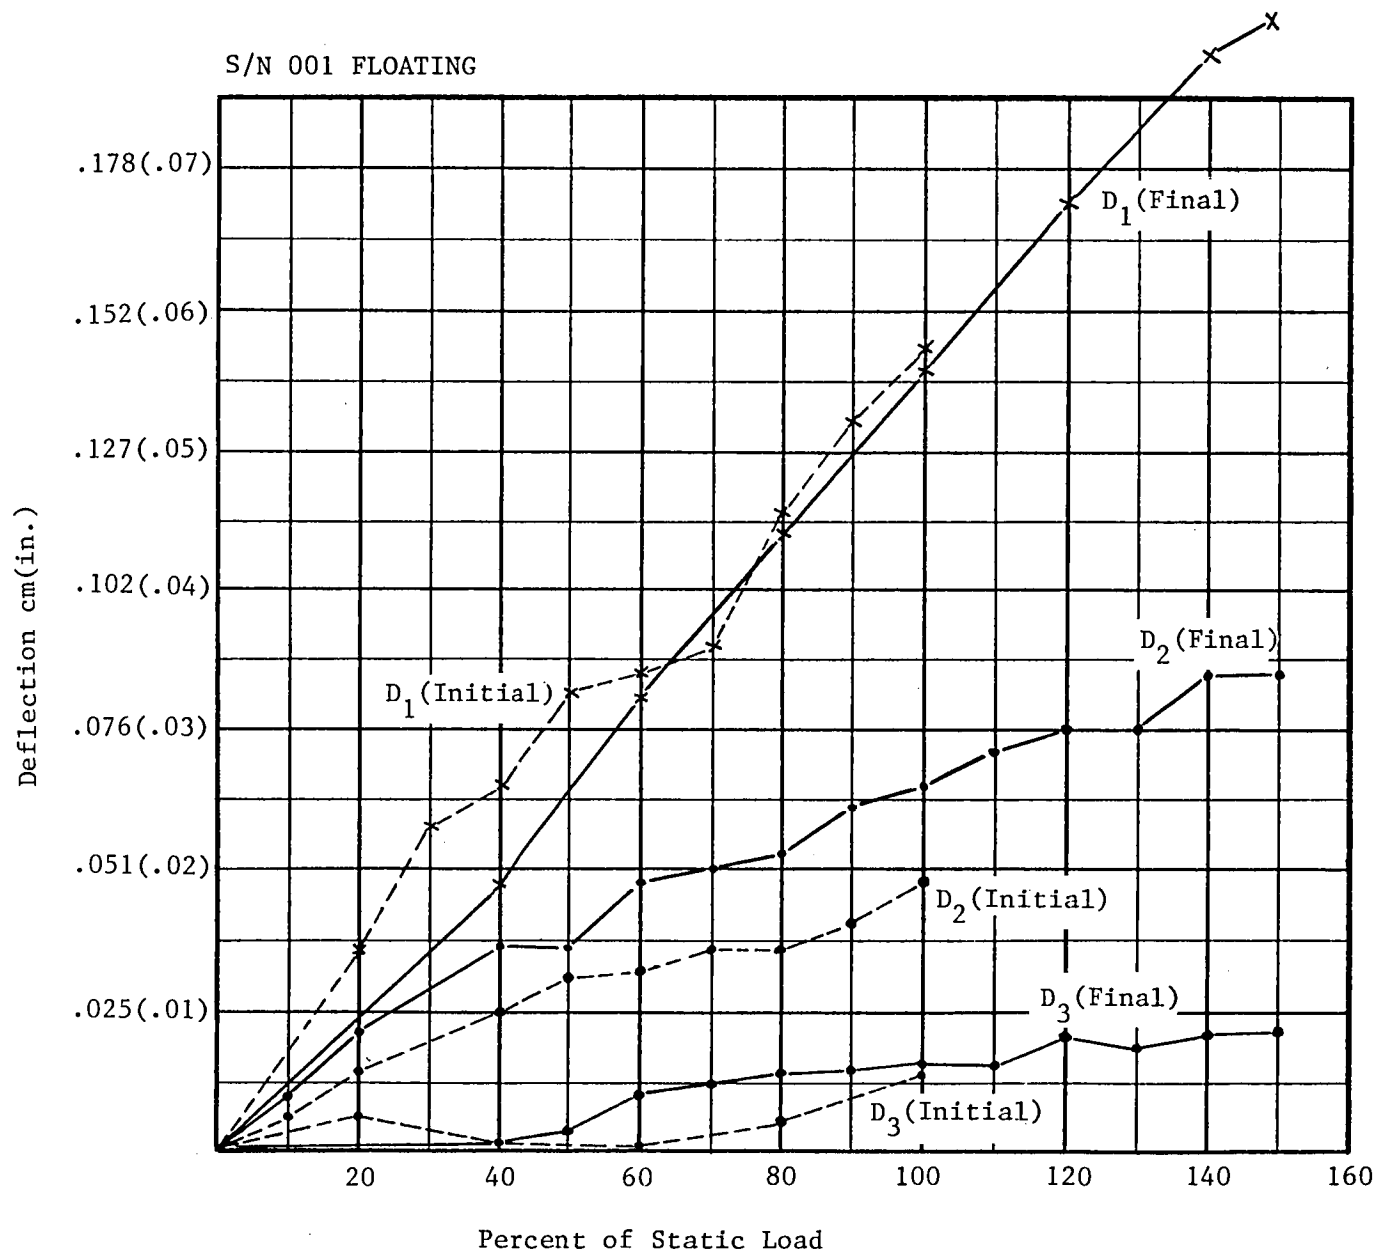
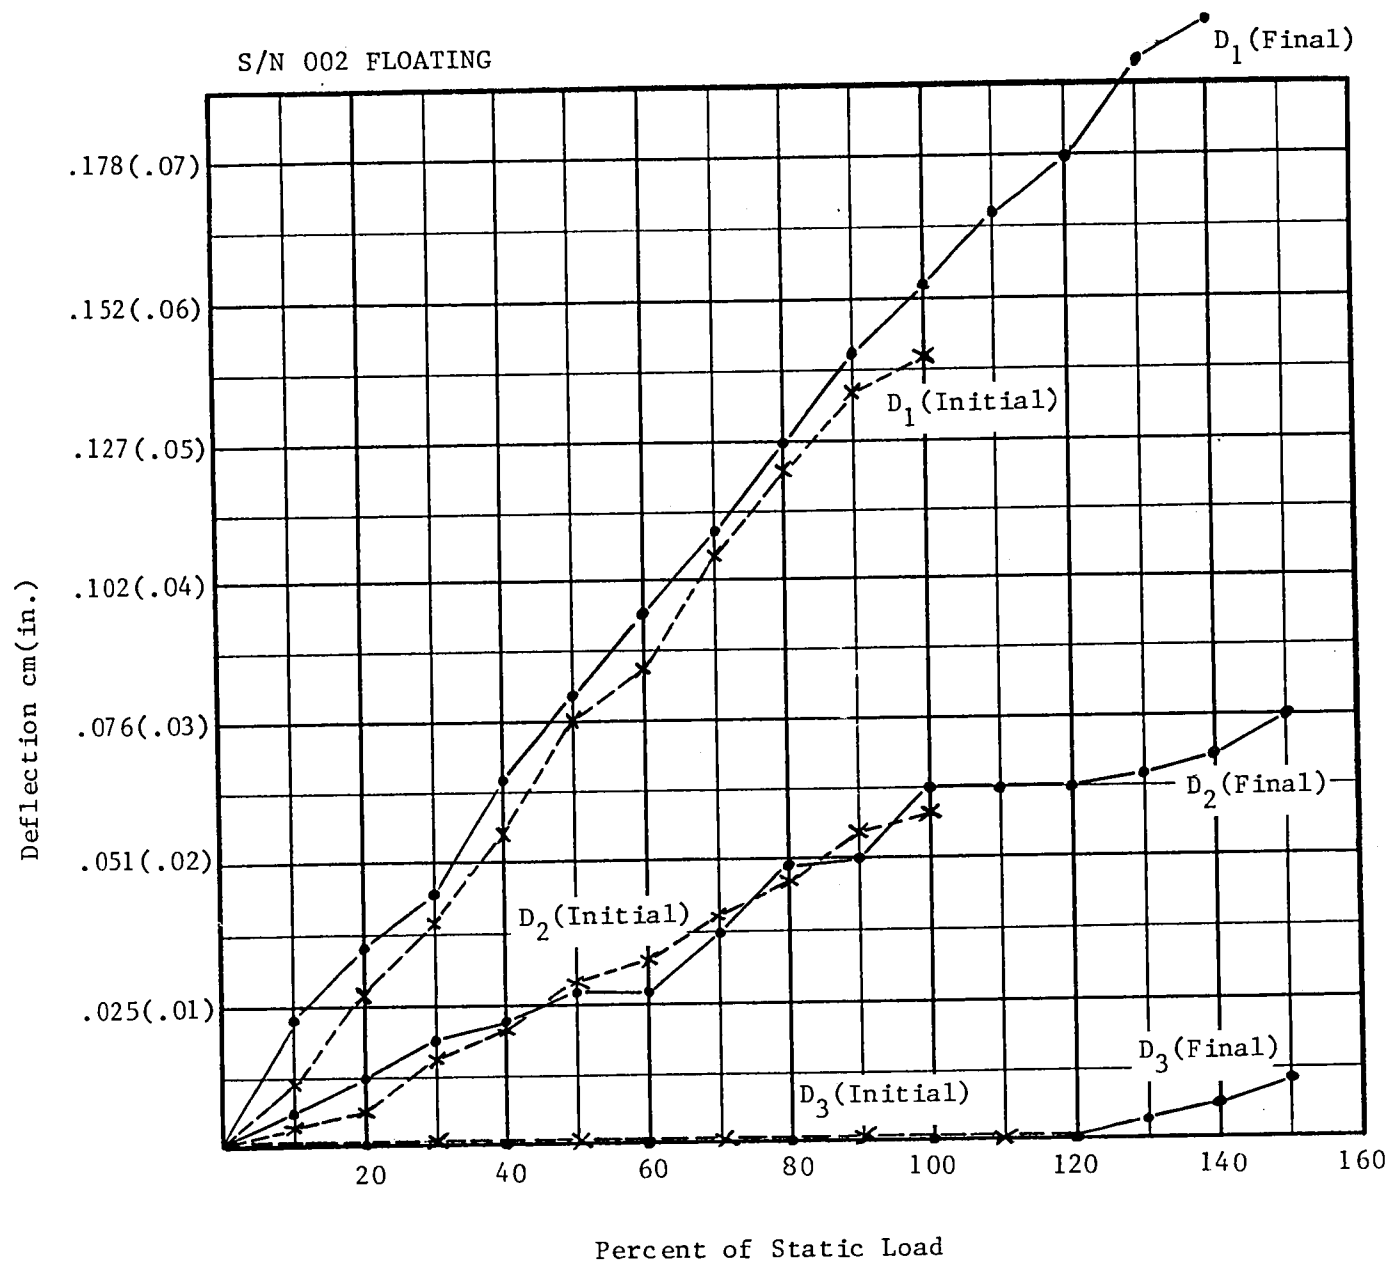
Figure IV-13 Floating Trunnion Static Test Deflection Data

Figure IV-13 shows static test deflection data for S/N 001 and 002 floating trunnions. In both cases, data were obtained before testing and after fatigue cycling of 22,540 and 20,000 cycles respectively for S/N001 and S/N002. After test deflection data for gages D_2 and D_3 when compared to

before test data indicate slight increases in trunnion deflection for S/N001. Data for S/N002 indicates virtually identical before and after test indications.

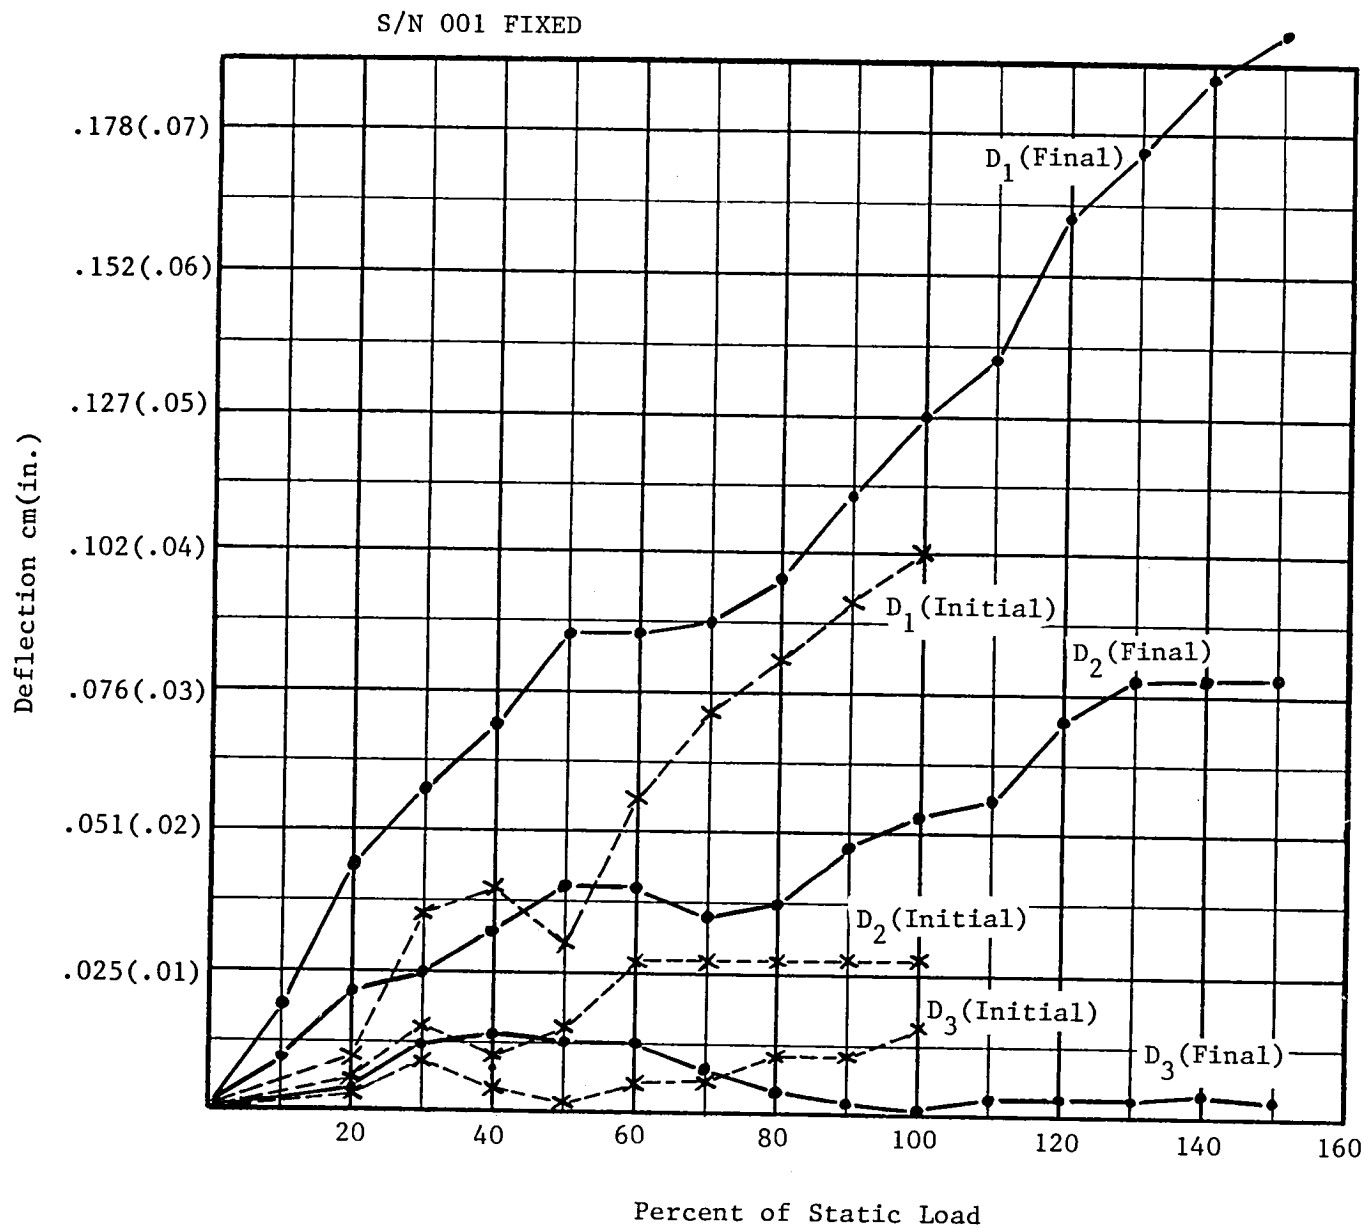
Figure IV-15 Fixed Trunnion Static Test Deflection Data

Figures IV-15 and IV-16 present similar static test deflection and strain data for the S/N001 fixed trunnion which was loaded for 22,540 cycles over an assumed profile up to and including ultimate load. The deflection data indicates an increase in deflection after the test (an indication of damage due to reduction in modulus). However, strain gage data indicates almost no change in before and after indications. This data supports the conclusion that minimal damage resulted from the cycling.
